## VISTA DEL MONTE

### Project Description

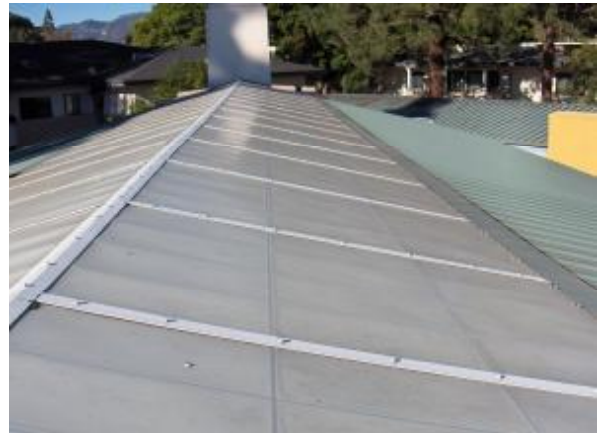
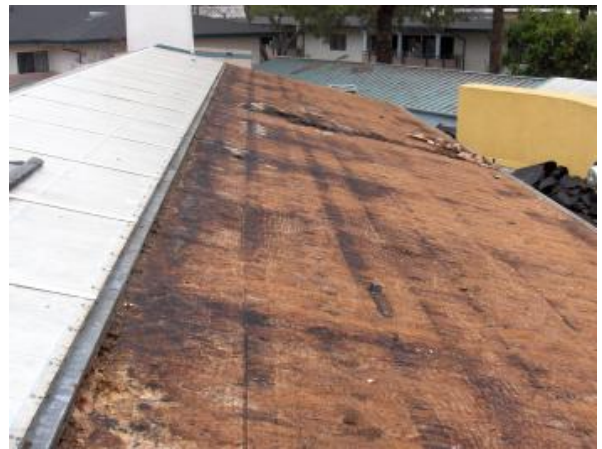
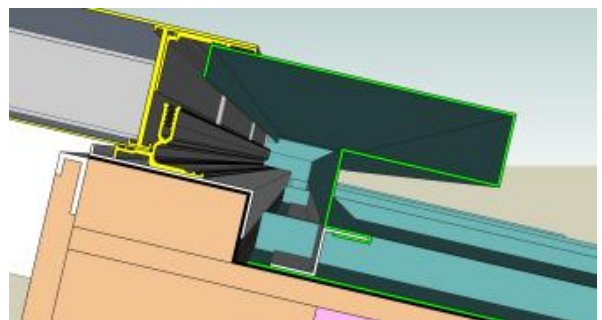
- Floor Area: 8,094 sq ft
- Number of Stories: 1
- Use/Occupancy: Pool facility
- The existing pool roof suffered premature failure due to excessive moisture build-up in the unvented rafter space and roof sheathing material. This required forensic investigation to determine the causes of moisture ingress, which were a combination of interior vapor from the pool in addition to external moisture that penetrated at the original interface detailing between the skylight and the metal roofing. Repair of the damage required full removal of the skylight, roofing materials, and roof framing assembly. Only the steel bent framing over the pool remained.

- The introduction of an air and vapor barrier assembly under the new vented roof assembly presented several challenges.

- RDH worked with the owner and the architect to reach a solution to the enclosure issues and recommended detailing improvements that addressed both the interior and exterior sources of moisture.
